**Recent Developments in Large Generator Repair Solutions  
and  
Monitoring Systems**

**K. Weigelt  
D. J. Graves  
Generator & Motor Services, Inc.**

**EPRI – Generator Predictive Maintenance & Refurbishment  
Conference  
December 2, 1998**

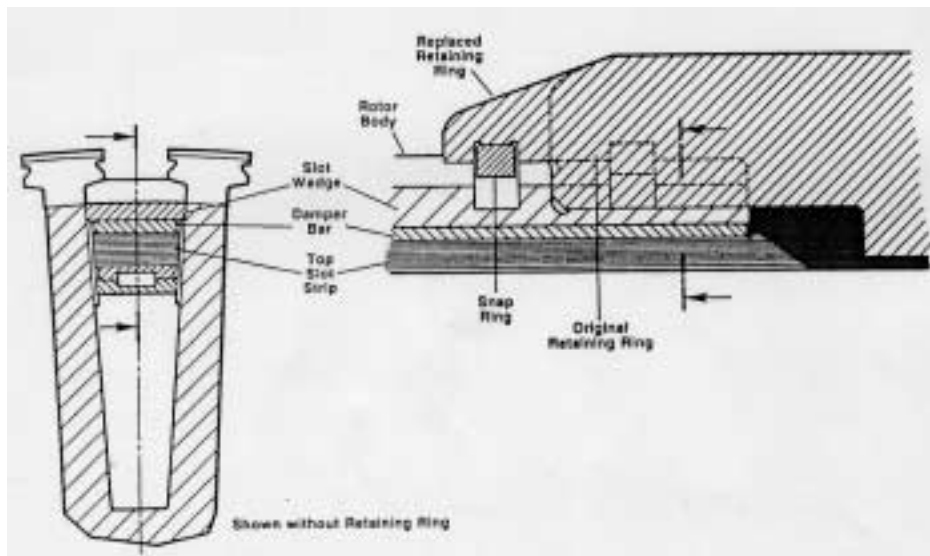
**Fig. 1: Modified shrink-fit area for the long ring modification.**

The solution described in the above mentioned papers can be performed on site or in shop without a rewind and requires new longer retaining rings. This solution is termed the "long ring modification" (Fig. 1).

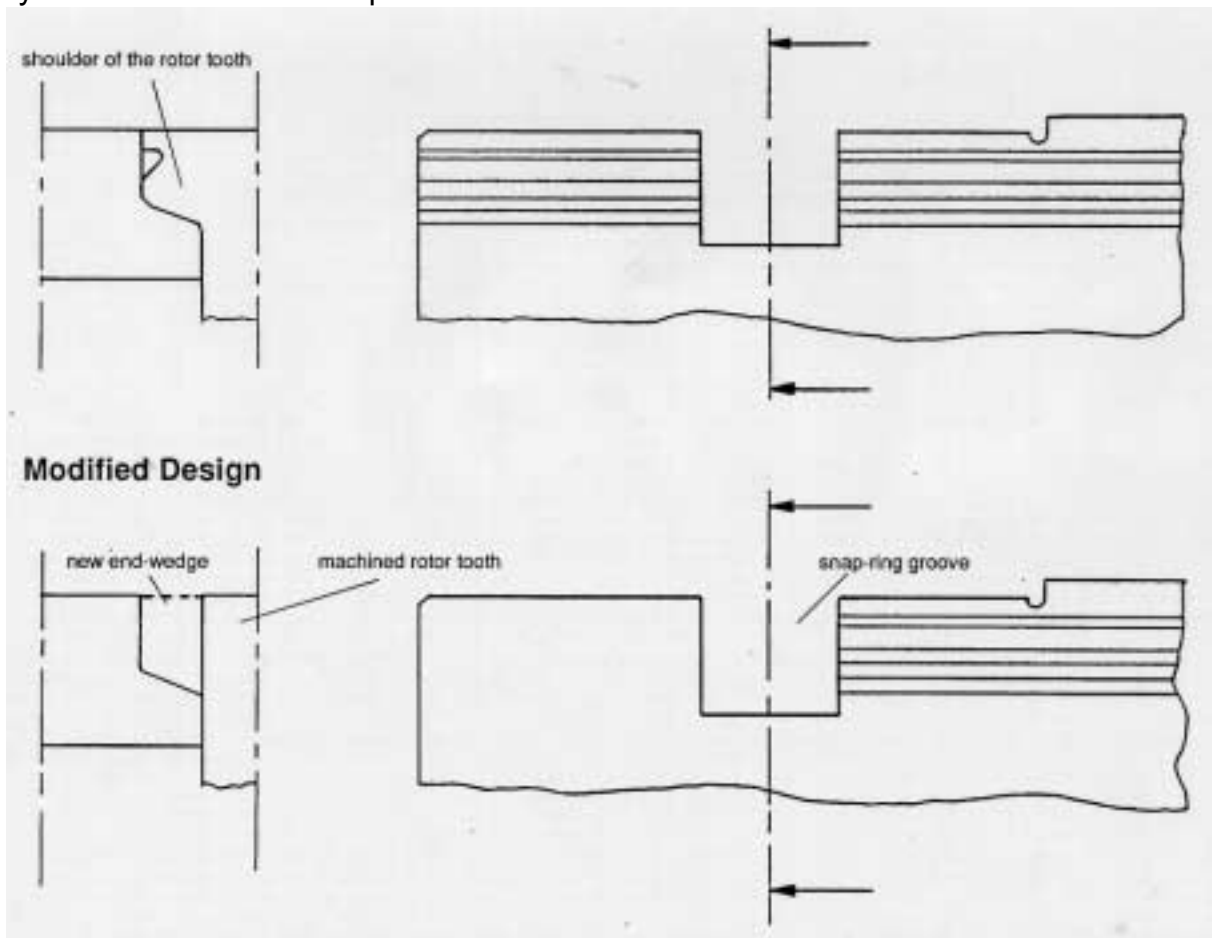
**Fig. 2: Comparison between the original design and the proposed modification. In the proposed modification the shoulders of the rotor teeth between the snap-ring groove and the end of the rotor body are machined off. The original end-wedges may be replaced by new end-wedges adapted to the new slot geometry.**

In order to remove the cracks and at the same time to relieve the rotor teeth in the region between the end of the rotor body and the snap-ring groove, the tooth shoulders in this region are machined off ( see Figure 2 ). Thus the excessive stresses due to the notches are eliminated.

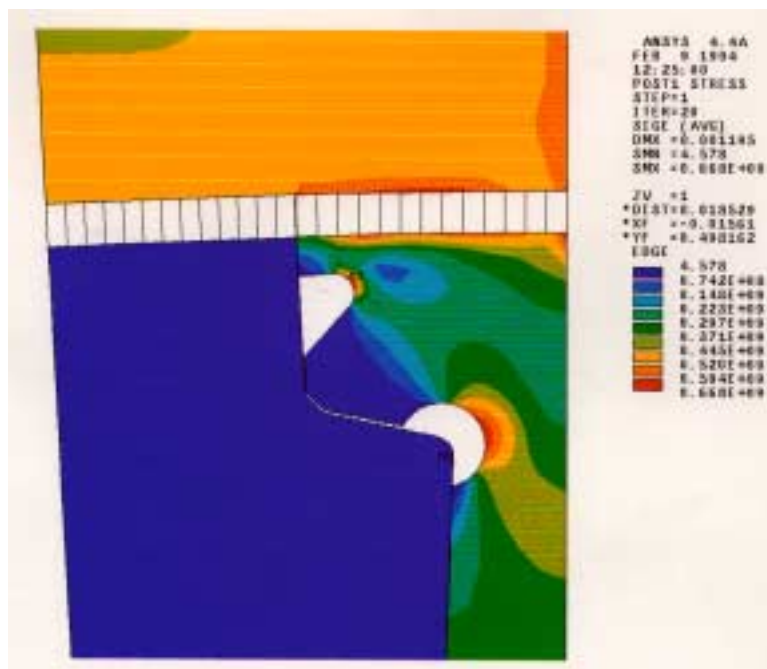
**Fig. 3: Equivalent elastic-plastic Mises Stresses (SIGE in N/m<sup>2</sup>) on a 40" rotor on the remachined rotor tooth at standstill. Radius of the machined fillet is 0.1 inch. Highest stress is 96.9ksi.**

For the remachining of the fillet radius normally a cutter with a 0.1 inch radius is used. Figure 3 shows the stress distribution on the machined rotor tooth at standstill and Figure 4 at rated speed. Both calculations show that with the remachined fillet radius the stresses are somewhat less compared to the original design (see Figure 5 and Figure 6) but still too high to prevent crack initiation from re-occurring. The crack initiation time with the fillet radius is not increased by a significant margin.

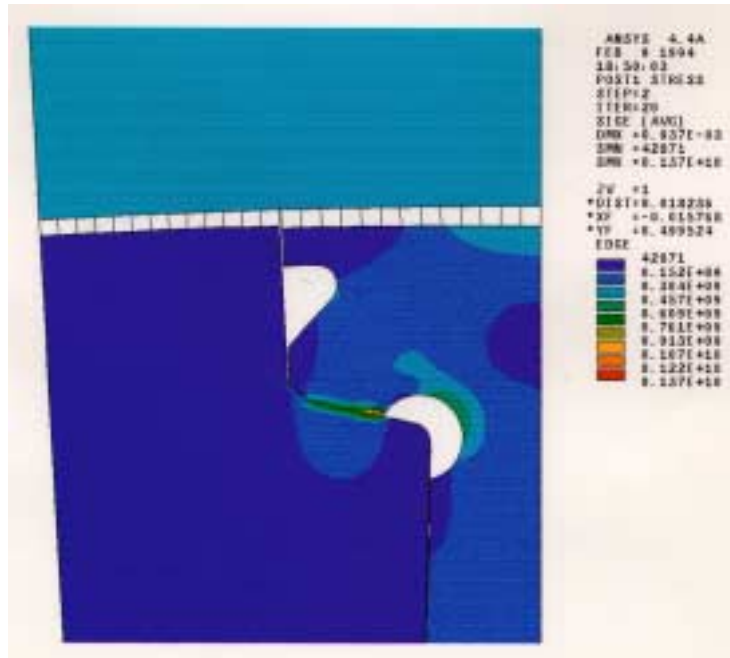
**Fig. 4: Equivalent elastic-plastic Mises Stresses (SIGE in N/m<sup>2</sup>) on a 40" rotor on the remachined rotor tooth at rated speed. Radius of the machined fillet is 0.1 inch. Highest stress is 198.7ksi.**

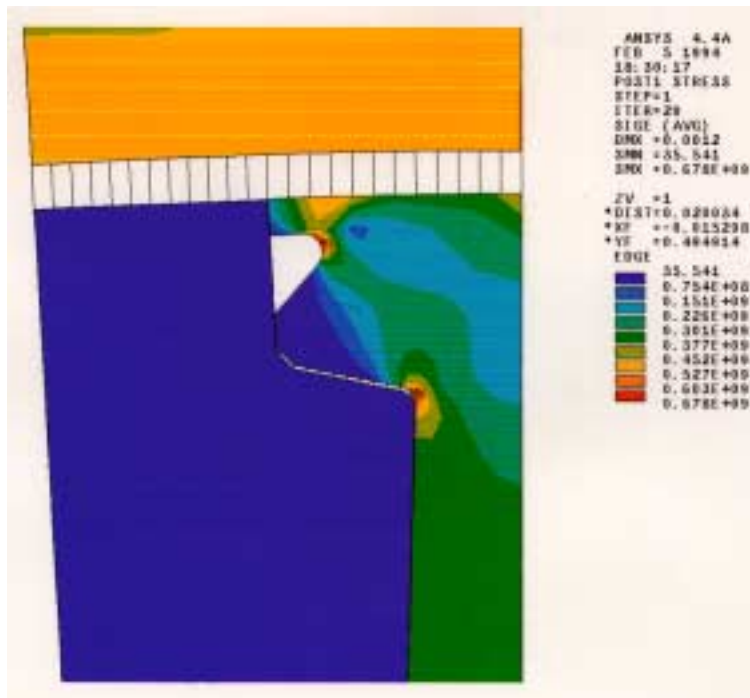
**Fig. 5: Equivalent elastic-plastic Mises Stresses (SIGE in N/m<sup>2</sup>) on a 40" rotor at standstill. Highest stress is 98.3ksi.**

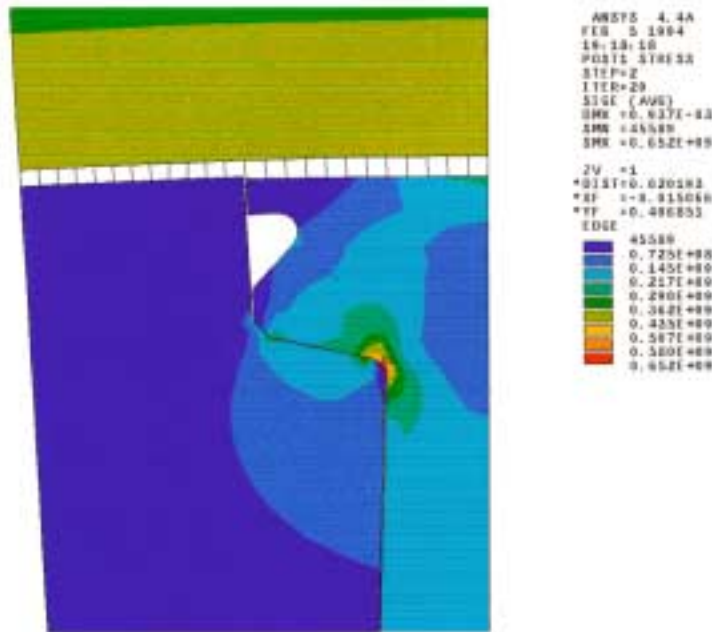
**Fig. 6: Equivalent elastic-plastic Mises Stresses (SIGE in N/m<sup>2</sup>) on a 40” rotor at rated speed. Highest stress is 94.6ksi.**

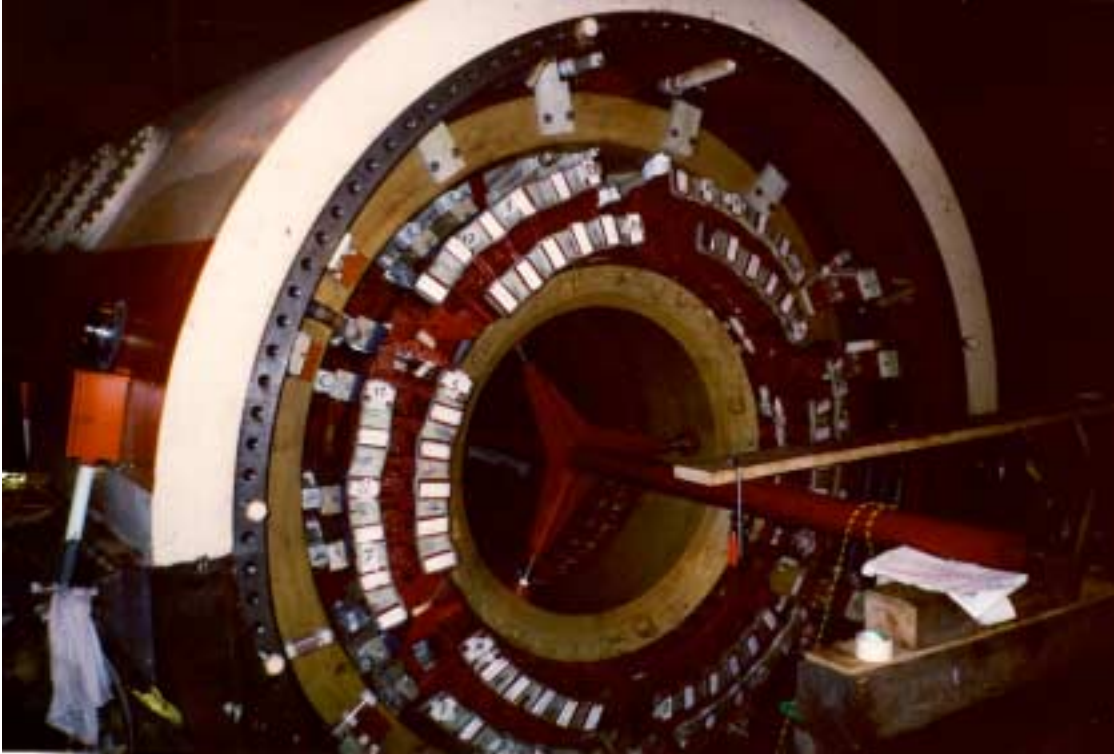
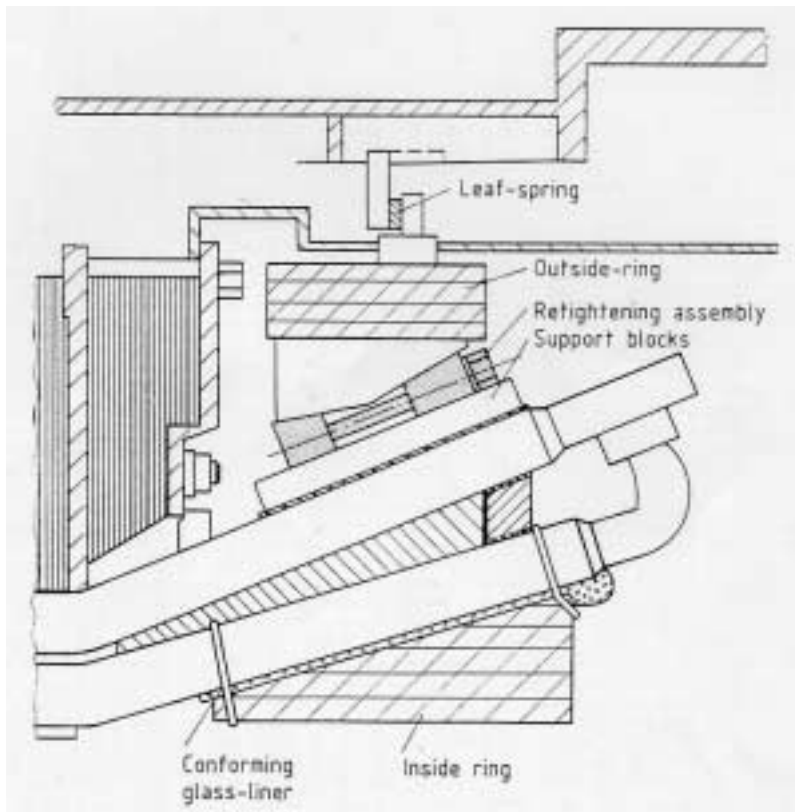
**Fig. 7: Modification with inner- and outer ring and parallel ring modification.**

The installation of the outside ring and the retightening assembly described in [3] requires the complete modification of the parallel rings (see Figure 7).

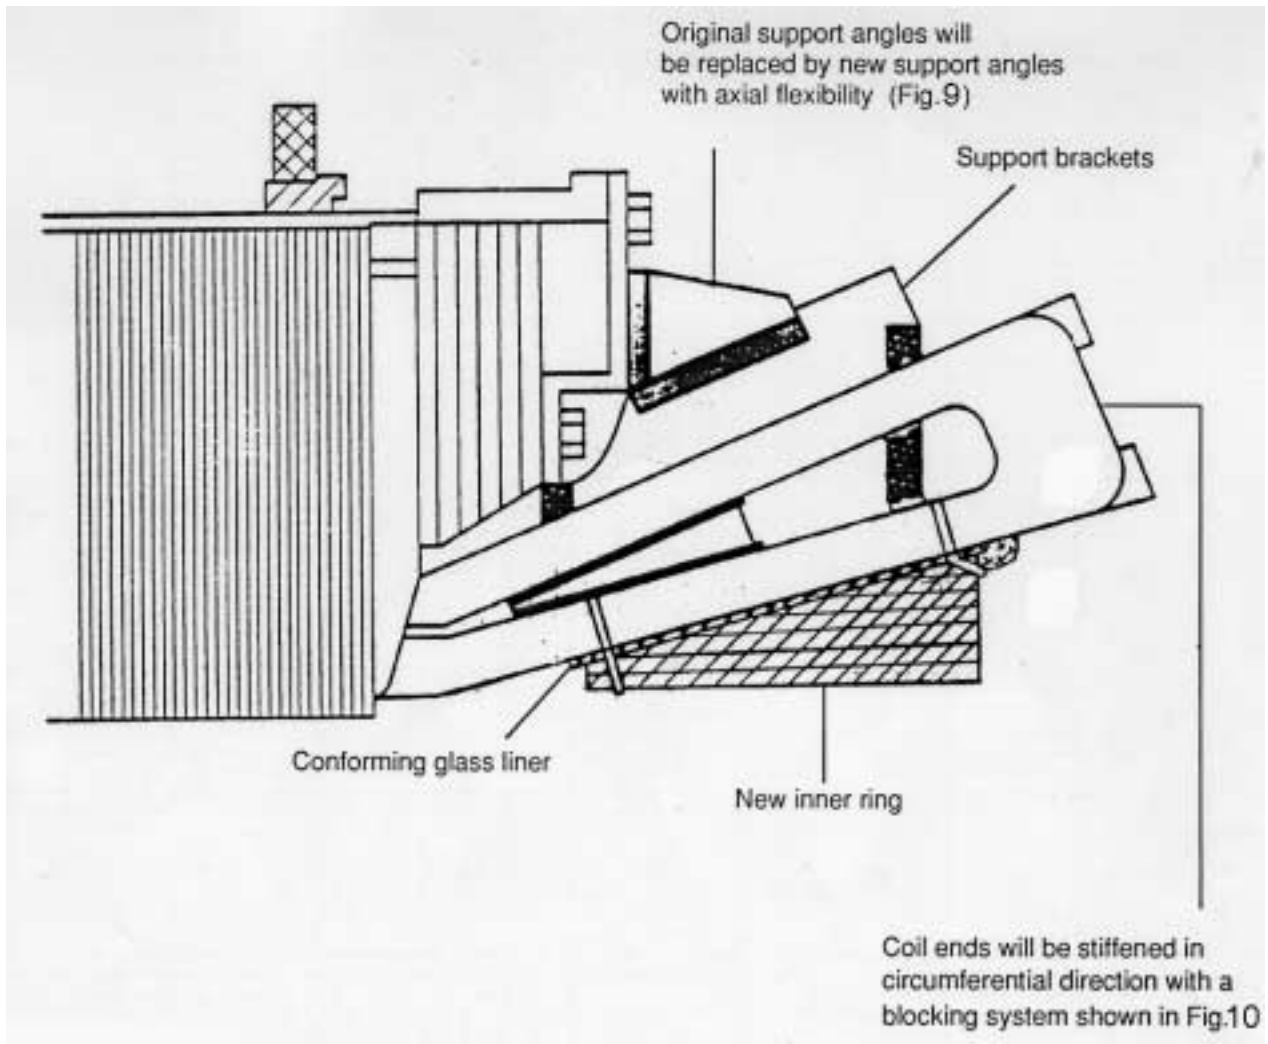
**Fig. 8: General end-winding arrangement (with the inner ring only)**

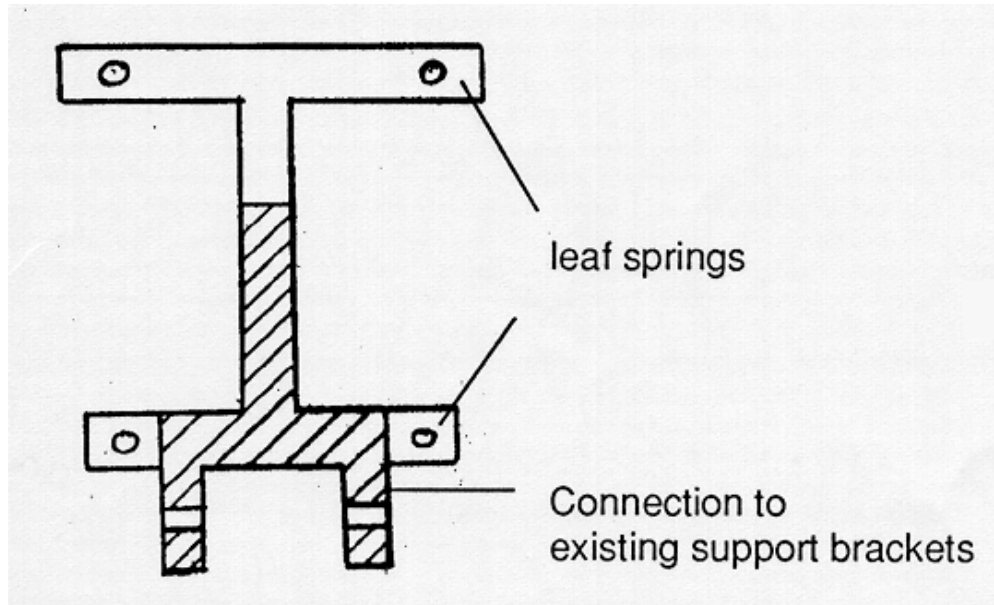
**Fig. 9: New support angles with axial flexibility.**

In order to provide high radial stiffness and axial flexibility for the thermal expansion of the windings, the existing support angles are replaced by new axial flexible support angles. In addition a stiff inside wound glass epoxy ring in combination with a conforming glass liner filled with epoxy resin is installed. This consolidates the end-windings to eliminate movement between critical components. This is shown in the Figures 8 and 9. The two inner rings on the turbine end and exciter end may be different because of different cone angles of the end-winding baskets. Both inner rings are shaped in such a way that the hydrogen gas flow is not affected.

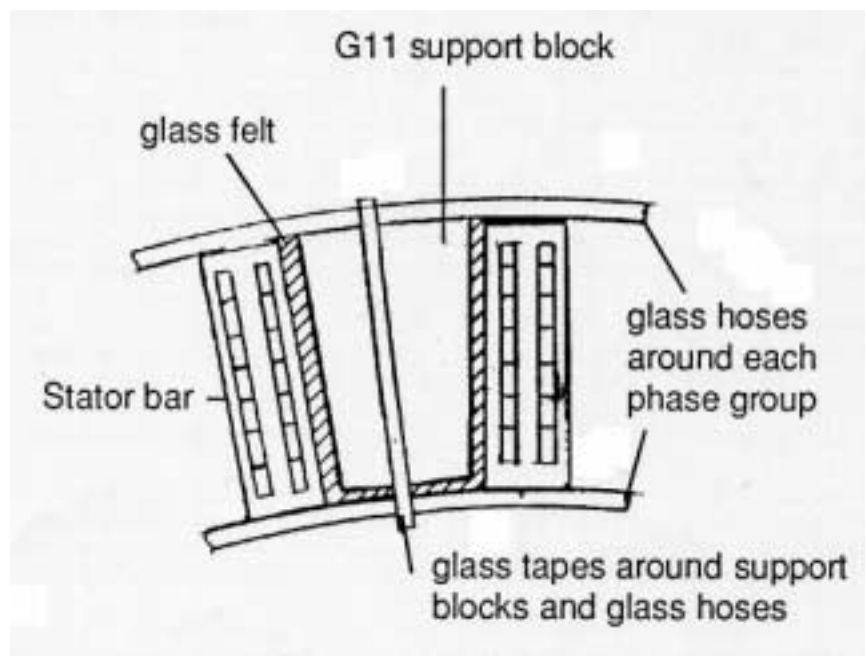
**Fig. 10: New circumferential blocking system.**

The stiffness in the circumferential direction is increased by a blocking system shown in Figure 10. This blocking system is installed between all the stator bars of each phase group on the outboard end of the end-windings. The G11 support blocks are adapted to the actual geometry in a manner shown in Figure 10. An important point with this alternative solution is that it easily facilitates the inspection and retightening of the core bolt nuts.

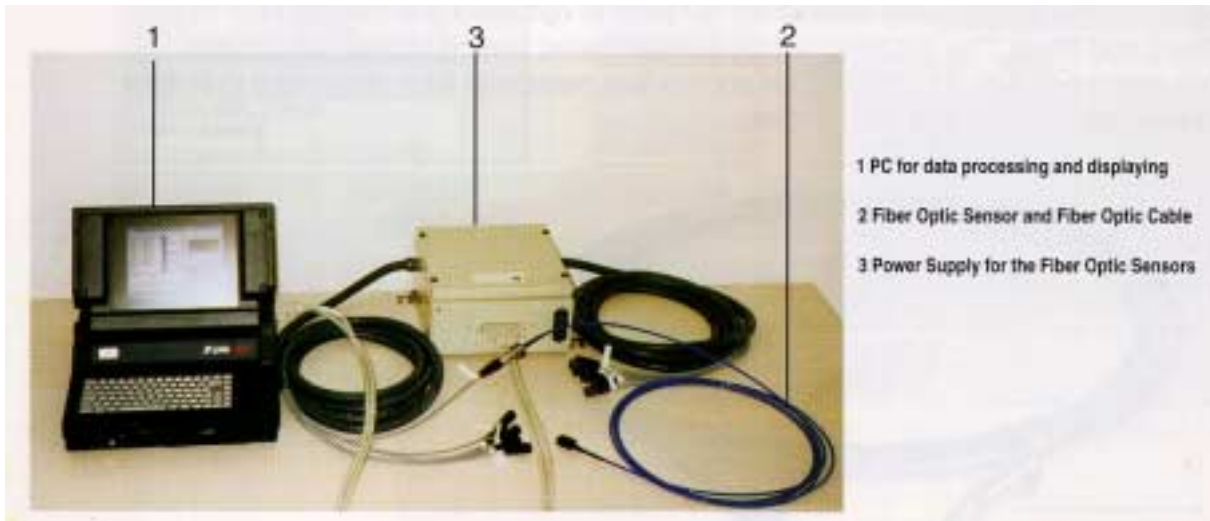
**Fig. 11: Fiber optic system with 12 fiber optic measuring channels.**

A modern, reliable and efficient system of measuring, displaying, evaluating and storing of large amount of measurement data has been developed to achieve the goal of end winding vibration monitoring ( see Figure 11 ).

A software system for Windows installed on a PC is used for data processing and display ( see Figure 11 ). It provides outputs proportional to vibration acceleration and displacement. A digital signal processing performs a Fast Fourier Transform (FFT) and the data is presented in the form of a amplitude-frequency spectrum to the operator.

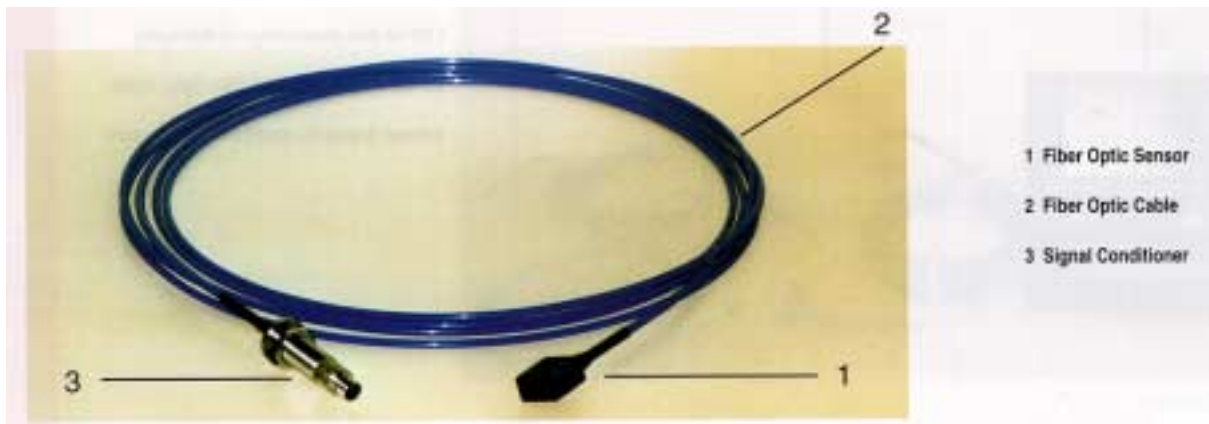
**Fig. 12: Fiber optic sensor with fiber optic cable and signal conditioner.**

The vibration sensor is shown in Fig. 12. The device is sensitive to vibration motion in one direction. Small size and the electrical isolation of the optical circuit allow the sensor to be mounted directly to the stator coil ends. The sensor head is located at the end of a three single strand multimode optical fiber glass cable. One fiber carries the light generated by the conditioning electronics for illumination. The sensor head returns two optical signals of variable intensity through the remaining fibers.

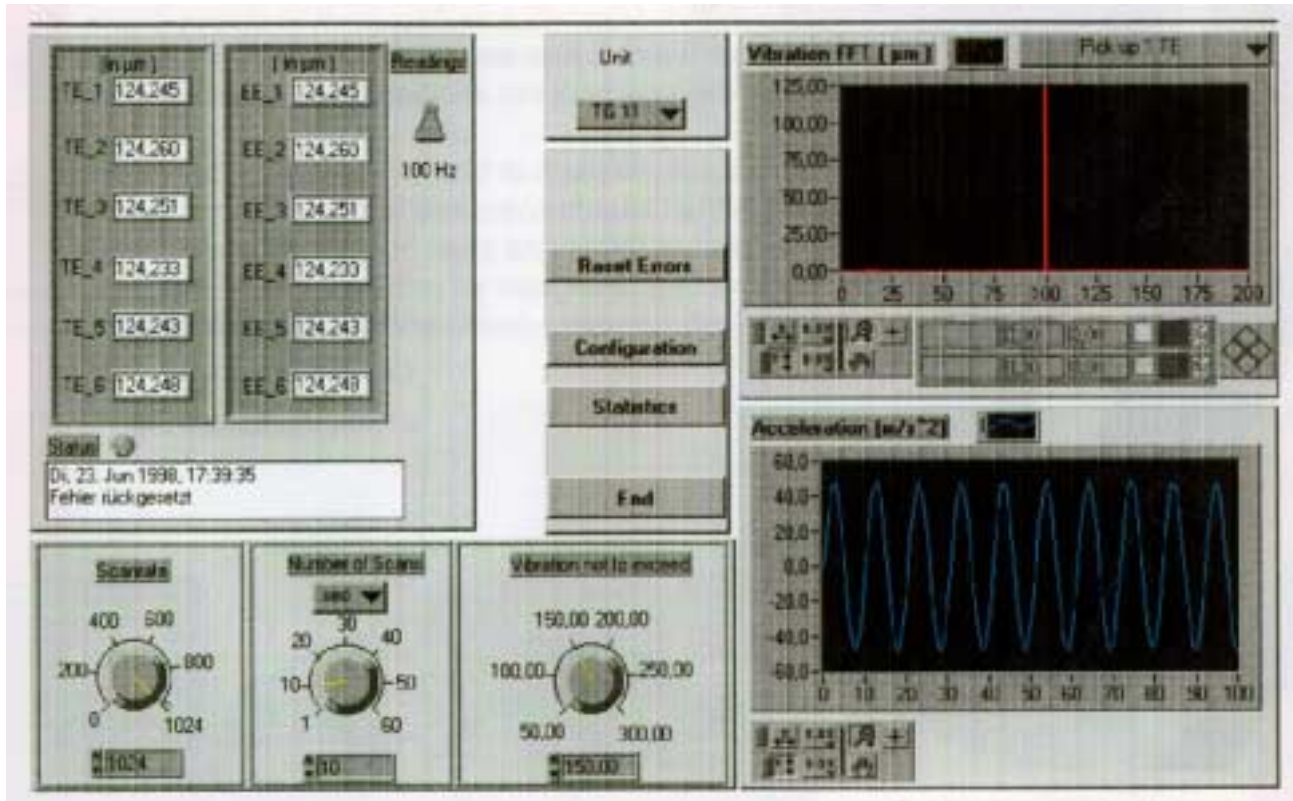
**Fig. 13: Front panel of the generator end-winding monitoring system.**

The front panel of the data processing and display system is shown in Figure 13. The Fiber Optic system can be installed in generators during an outage and be upgraded to a complete Generator Monitoring System.

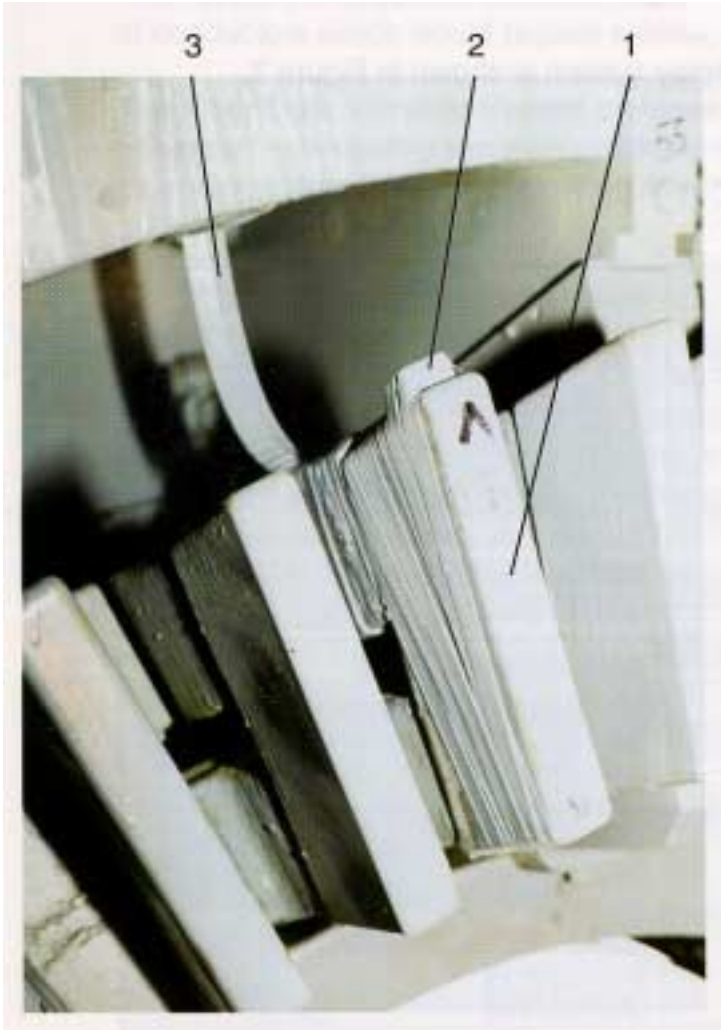
- 1) High Voltage Stator End-Winding
- 2) Installed Fiber Optic Sensor
- 3) Routing of the Fiber Optic Cable

**Fig. 14: Installed fiber optic sensor.**

Figure 14 shows a Fiber Optic Sensor installed on a high voltage stator end-winding.
